## **Fouling Investigation of Brazed Plate Heat Exchangers**

**David J. Kukulka**

**Edward S. Czechowski**

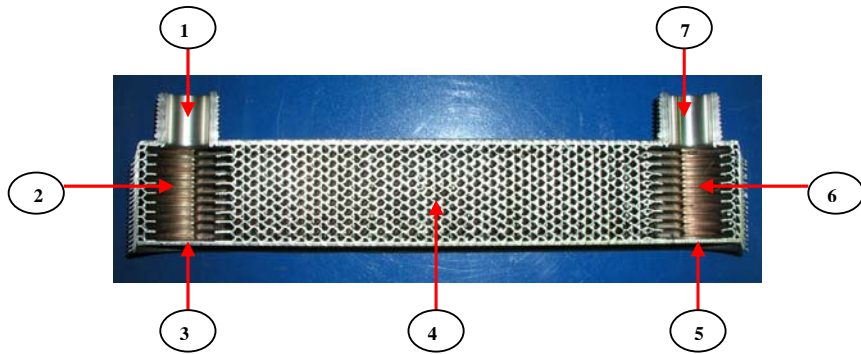
**Figure 2 Brazed Plate Heat Exchanger  
Observation Locations**

Figure 2 shows the locations in the exchanger that were evaluated. The areas examined provide a comprehensive representation of the fouling in a brazed heat exchanger. Table 1 provides fouling amounts and conditions considered. A decrease in the rate of fouling can be seen after the exchanger has been cleaned. Perhaps this is the result of the inhibitor being applied at the time of cleaning and the surface energy being changed. Figure 3 shows a comparison of fouling at various locations in an exchanger that has been in service for one year. It shows the characteristics of the fouling and how severe the fouling was after one year of operation.

Initially, the exchanger surface consisted of a shiny smooth metallic finish. For short run cases, surface deposits gradually develop and were spotty and not consistent. Several areas on the exchanger contained large amounts of deposits that were easily flaked from the surface, whereas in most areas the material appeared to adhere to the surface and was not easy to remove.
